Bone Lake Watershed

Fact Sheet

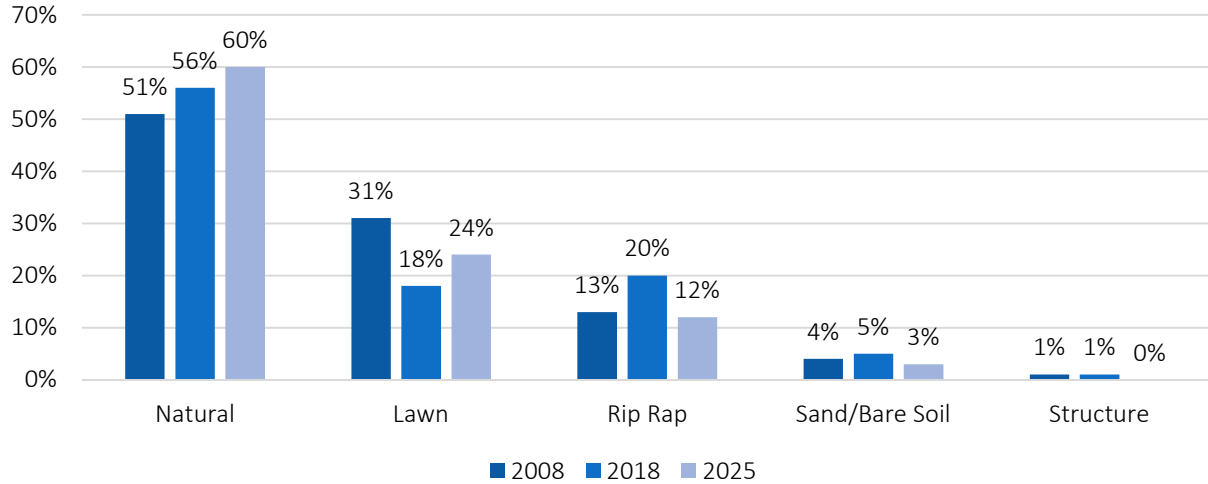
Shoreline Edge

The objectives of the native planting projects are to improve habitat next to the water, reduce runoff from waterfront properties, and stabilize shorelines with deep roots of native plants. Some lake residents simply allow vegetation along the shoreline to grow which can accomplish the same objectives. Shoreline surveys completed in 2008, 2018, and 2025 provide a progress report for Bone Lake. In all three surveys, natural vegetation was the

predominant ground cover at the water's edge, with the amount of natural vegetation increasing each year since 2008.

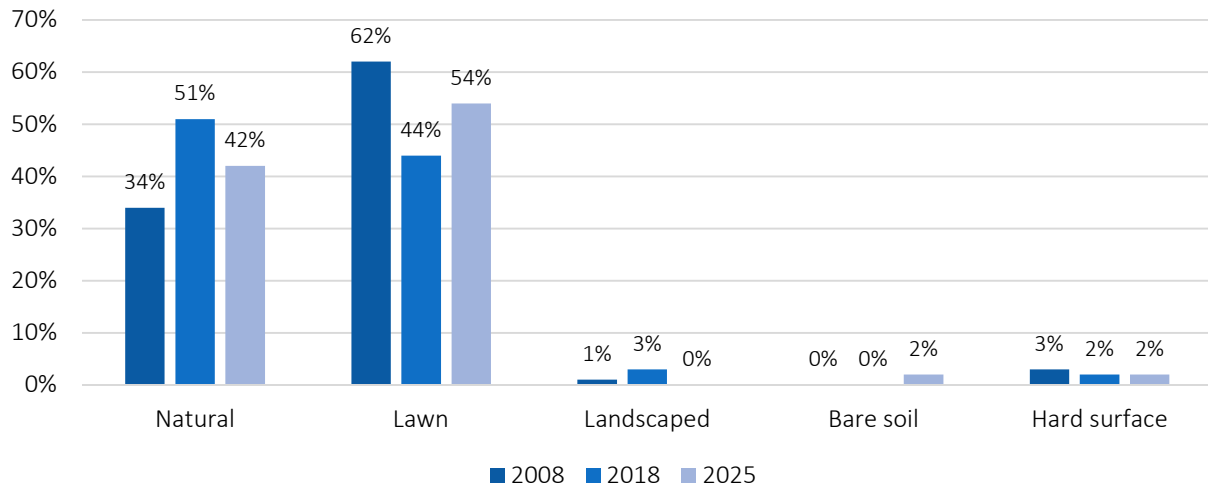
Riparian Buffer Zone

However, when considering the entire area from the water's edge to 35 feet from it (the riparian buffer zone), the amount of natural ground cover increased from 2008 to 2018 then decreased from 2018 to 2025. Conversely, the amount of lawn in the riparian buffer zone decreased from 2008 to 2018 and increased from 2018 to 2025.
